WWS Performance Management Report

August 2011

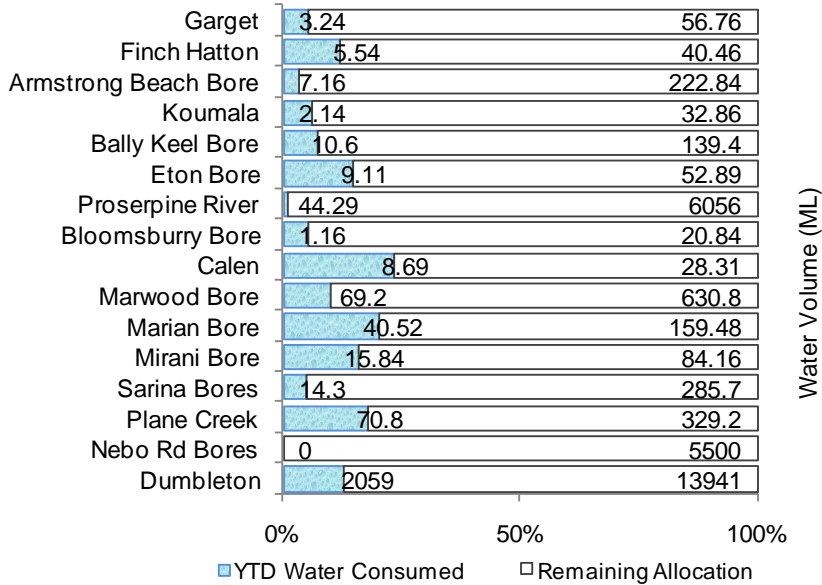
Water Services has a water allocation or water license for each water source. The water allocation and year to date water consumption for each of the water sources is detailed below.

Calen water use remains high with water being used for road maintenance.

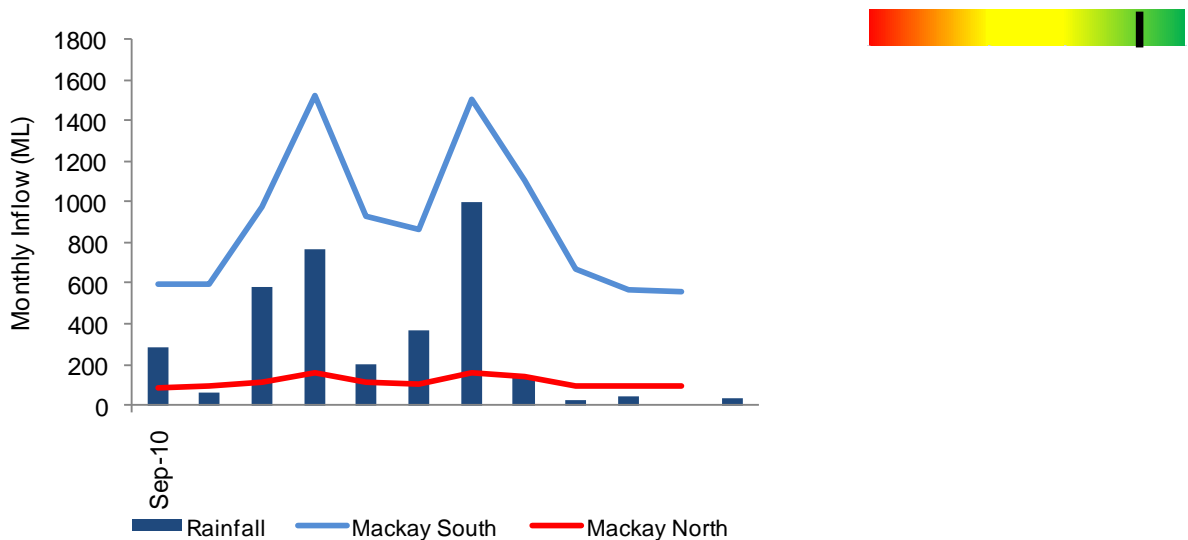
The inflow into Wastewater Treatment Plants is impacted by the number of sewage connections and the extent of inflow and infiltration. The monthly inflow into the Mackay North and Mackay South Water Recycling Facilities is detailed below.

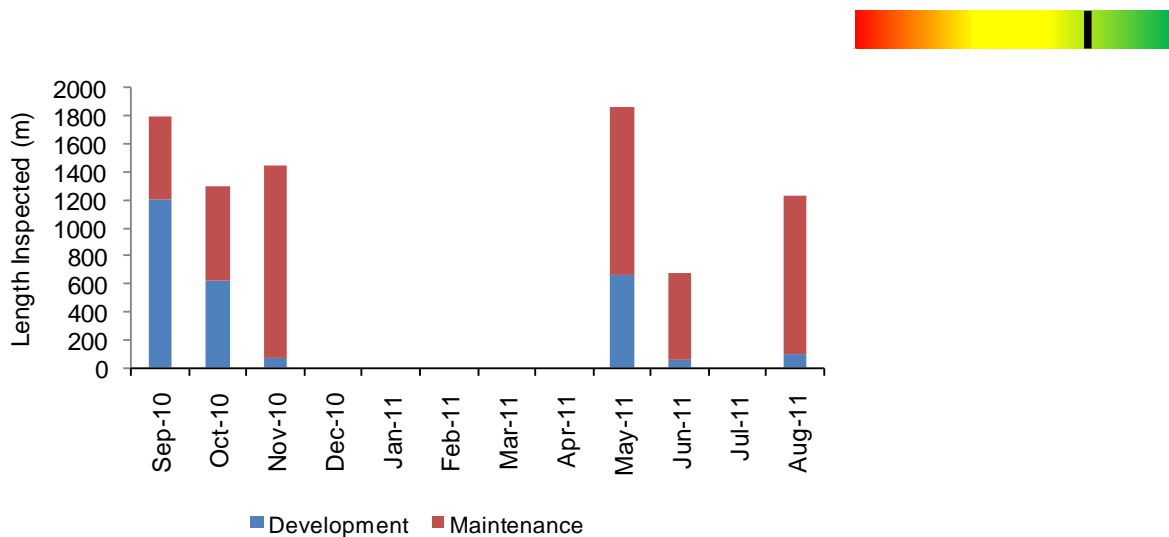
To protect and identify defects in the sewer system Water Services routinely undertakes CCTV inspections of the sewer system. CCTV inspections are undertaken for both developers as part of the process to create a new subdivision and on existing sewer assets as part of the routine sewer inspection program. A summary of the CCTV activity is displayed below measured as meters of sewer inspected.

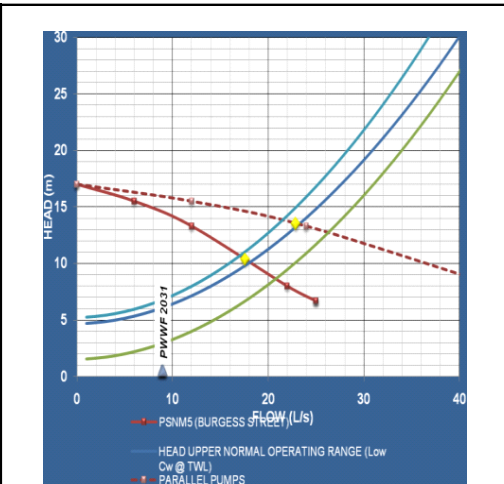
Pump Delivery into relocated rising main

Burgess Street SPS Rising Main relocation.			
Status	% Complete	Budget	Time
Planning	75%	•	•
Comment		Program	P&S
Planning investigation to determine if it is feasible for delivery to be re-routed to the adjacent catchment. Preliminary Est. Capital Works value \$350k. Benefit is anticipated to be a direct reduction in overflow and spillage incidents in the area of the SPS and in the Gooseponds SPS Catchment. The attached graph shows that the hydraulic equations for the proposed system delivery balance. Hydraulic modelling to confirm no problems downstream of Oasis Drive SPS is underway.

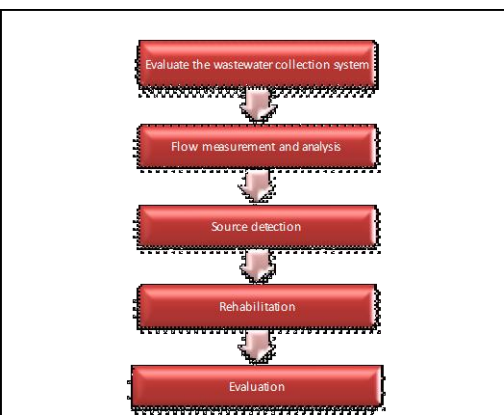
Components of I&I management

Inflow & Infiltration Audit Planning Investigation & Pilot			
Status	% Complete	Budget	Time
Planning	75%		•
Comment		Program	P&S
Planning investigation into two interdependent aspects: Determine improved reporting and monitoring and control of I&I program.

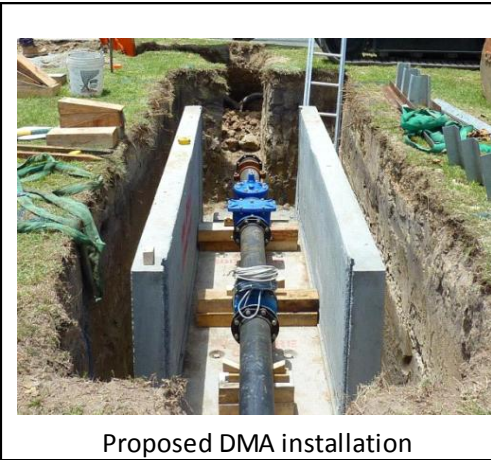
Proposed DMA installation

Demand Management: District Metered Areas (DMA's)			
Status	% Complete	Budget	Time
Planning	95%	•	•
Comment		Program	P&S
5 concept DMA's have been identified for detailed design, followed by construction. DMA's provide the best practice basis for assessing leakage levels on a continuous basis. Flow meters, instrumentation and fittings have been procured. A design package has been issued to Infrastructure Delivery for comment. The first DMA will encompass Slade Point.

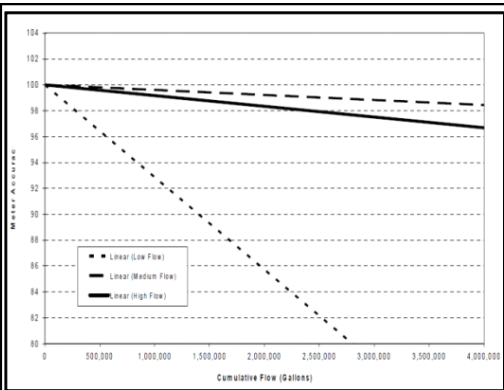
Meter error vs cumulative volume passed

Domestic Meter Replacement Strategy			
Status	% Complete	Budget	Time
Planning	95%	•	•
		Program	P&S
Planning investigation into Economics based meter replacement. Includes for a Contract Project Specification for procurement in 2011/2012. Technical Specification is now complete and MIA is attending to 2nd formal review comments.

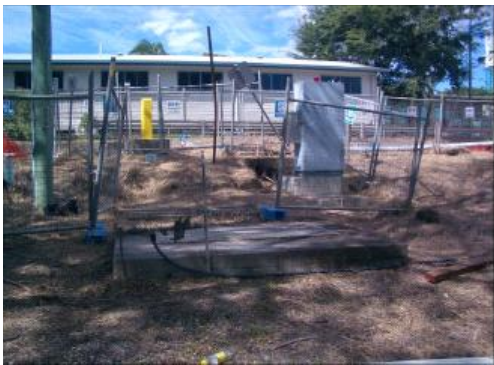
<p style="text-align: center;">Existing Pump Station</p>		Planning	95%

Base Hospital Sewer Pump Station Upgrade					
		Status	% Complete	Budget	Time

Comment		Program	P&S
<p>This report summarises the planning undertaken to date for the Base Hospital Sewage Pump Station (SPS) upgrade. It outlines the requirement for the project to proceed through to detailed design to meet Mackay Water Services' (MWS) standards.</p>					
Program	Project	Status	% Complete	Budget	Time
ID	Manhole Repairs	Planning	0%	•	•
Rolling annual programme - liaison with operations and identification of projects commenced					
Program	Project	Status	% Complete	Budget	Time
ID	Mirani Refurbishment & Enhancement	Planning/Design	60%	•	•
Process design complete, MIA allocated civil package, design in progress					
Program	Project	Status	% Complete	Budget	Time
ID	SPS - Goldsmith St SPS Upgrade	Planning/Design	90%	•	•
Civil, structural and electrical design documentation reviewed by WS and designers addressing comments. Construction TOC development and procurement underway					
Program	Project	Status	% Complete	Budget	Time

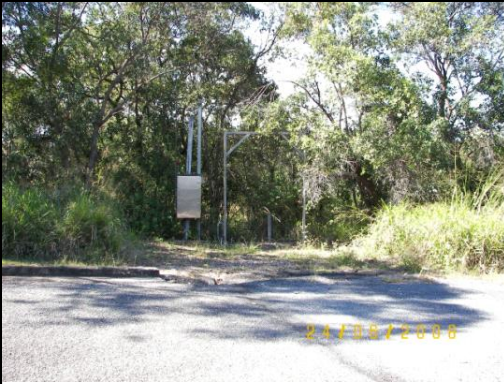
<p style="text-align: center;">existing SPS No.8 Utah Avenue</p>	SPS No. 8 Sarina			
	Status	% Complete	Budget	Time
	Planning/Design	0%	•	•
	Comment		Program	ID
Scope definition required CRITICAL ISSUES • Detailed planning brief and scope definition required to facilitate design

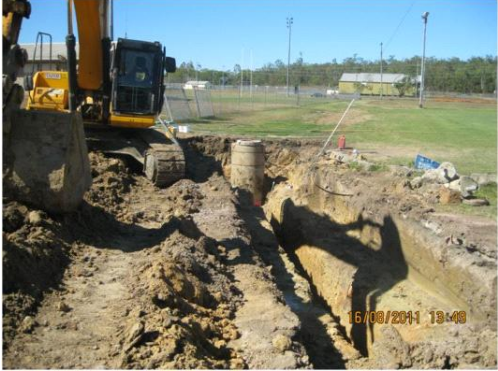
<p style="text-align: center;">MH10/1 Brewers Pk</p>	SPS No.2 Place Avenue - Rising/Gravity Main			
	Status	% Complete	Budget	Time
	Construction	85%	●	●
	Comment		Program	ID
Only MH11/1 in Brewers Pk to be completed along with the cut-in at Pump Station 1. Delay due to lead time on fittings after change of design.

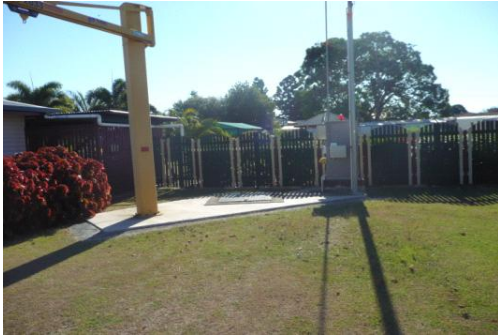
<p style="text-align: center;">existing SPS No.2 Place Avenue</p>	SPS No.2 Place Avenue - Pump Station			
	Status	% Complete	Budget	Time
	Procurement/Tender	70%	●	●
	Comment		Program	ID
Tenders for Pump Station Close 6/9/11 DERM notice has been received CRITICAL ISSUES • Electrical design not finished yet

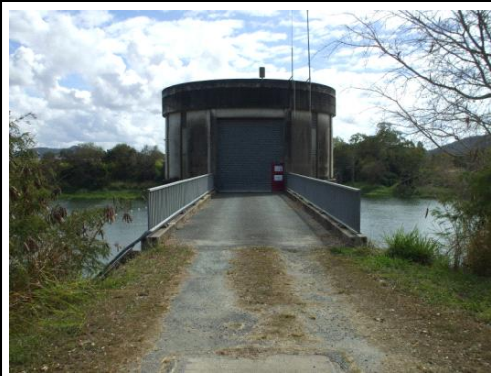
Dumbleton water intake tower

Dumbleton Raw Water Trunk Main and Pump Station			
Status	% Complete	Budget	Time
Construction	3%		
Comments		Program	ID
Interim upgrade implementation works underway, scheduled to complete end of Oct 2011 . Land negotiations complete, Site survey to commence soon. Construction Procurement underway

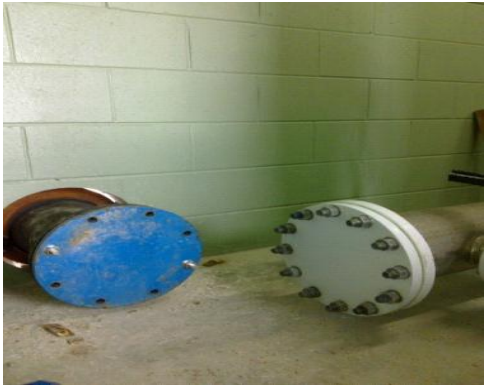
Ron Searle Drive				
	Status	Annual Budget	% Complete	Budget	Time
	Construction		95%	•	•
	Comments			Program	ID
The full length of new main was laid and Practical Completion has been issued to Vassallo CRITICAL ISSUES • Commissioning of the project on hold, Ops group resourcing problem impacting connection the new main to the pump station

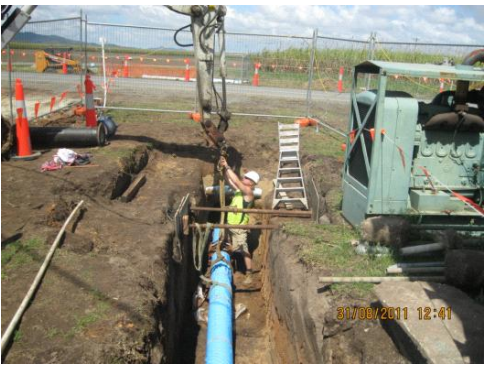
Marian Network Augmentation				
	Status	% Complete	Budget	Time	
	Construction		65%	•	•
	Comments			Program	ID
Contractor has completed the installation of 250 dia water main and underboring of the Mky -Eungella Rd. Construction of the pump station is underway. Booster Pumps are being installed. 150mm Marcam - Staytes WM work underway with the underboring of the QR rail completed. Drawings for Redesign of Mky-Eungella Rd road crossing at Daly St approved by QTMR.

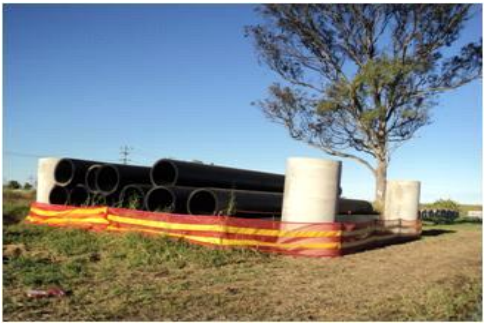
Bruce Highway (Stockroute Rd Intersection)			
	Status	% Complete	Budget	Time
	Construction	90%	●	●
	Comments		Program	ID
QTMR project out to Tender. Delivery of Principal supplied RCP envelopers complete CRITICAL ISSUES • Timing dependant on QTMR

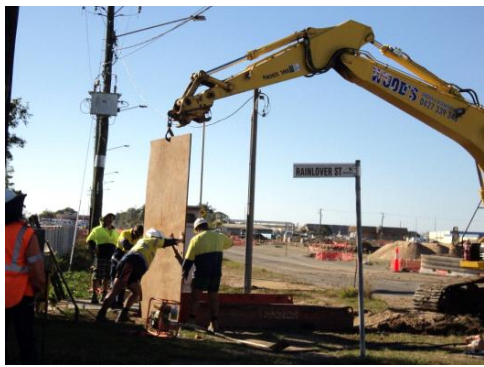
<p style="text-align: center;">Sheet piling for sewer MH</p>	Boundary Rd (Bruce Highway – Rainlovers St.)			
	Status	% Complete	Budget	Time
	Construction	80%	●	●
	Comments		Program	ID
Water and Sewer works in progress. New sewer connection at Rainlover pumpstation delayed.

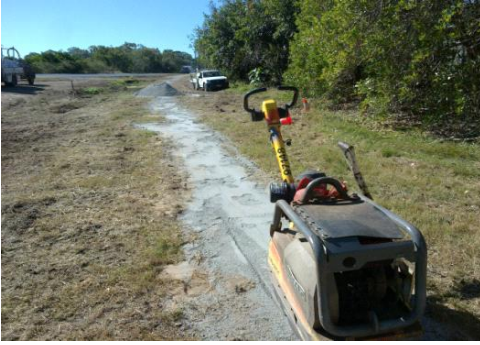
WMR - Eimeo Rd (Camilleri - Shann)				
	Status	% Complete	Budget	Time

Construction	100%	•	•
	Comments		Program	ID
	The full length of main was laid and restoration work completed. The new main was commissioned on 3 August 2011 CRITICAL ISSUES Survey information has been sent to Cardno for preparing As Con drawings

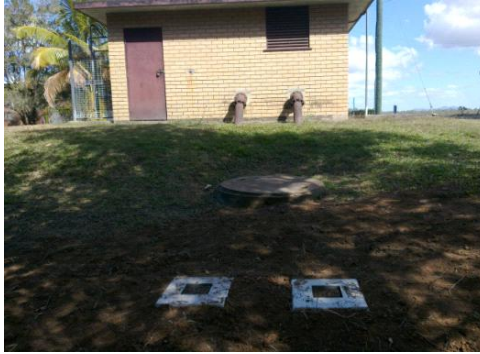
WMR Creek - Bold St - Walkerston				
	Status	% Complete	Budget	Time

Construction	100%	•	•
	Comments		Program	ID
	The new main was fully laid and connected to the network on 26 July 2011. Practical Completion has been issued to RNH. CRITICAL ISSUES Survey information has been sent to Cardno for preparing As Con drawings

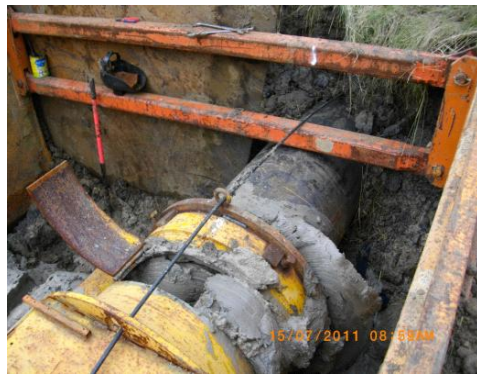
Underbore

Ø150 & Ø300 Shakespeare St (Stage 1)				
Status	Annual Budget	% Complete	Budget	Time
Construction		50%	•	•
Comments		Program	ID	
<p>The full length of Ø150 main (Stage 1) was laid and connected to the network including transfer of all properties services . The new main was commissioned on 18 August 2011</p> <p>CRITICAL ISSUES</p> <p>Roebuck Civil schedule to start laying Ø300 main on the northern side of Shakespeare St from Monday 12 Sep 2011 (Start from Milton St heading toward Sydney St)</p>
