Mackay Coasts and Communities

Haliday Bay

Beach Plan

2010

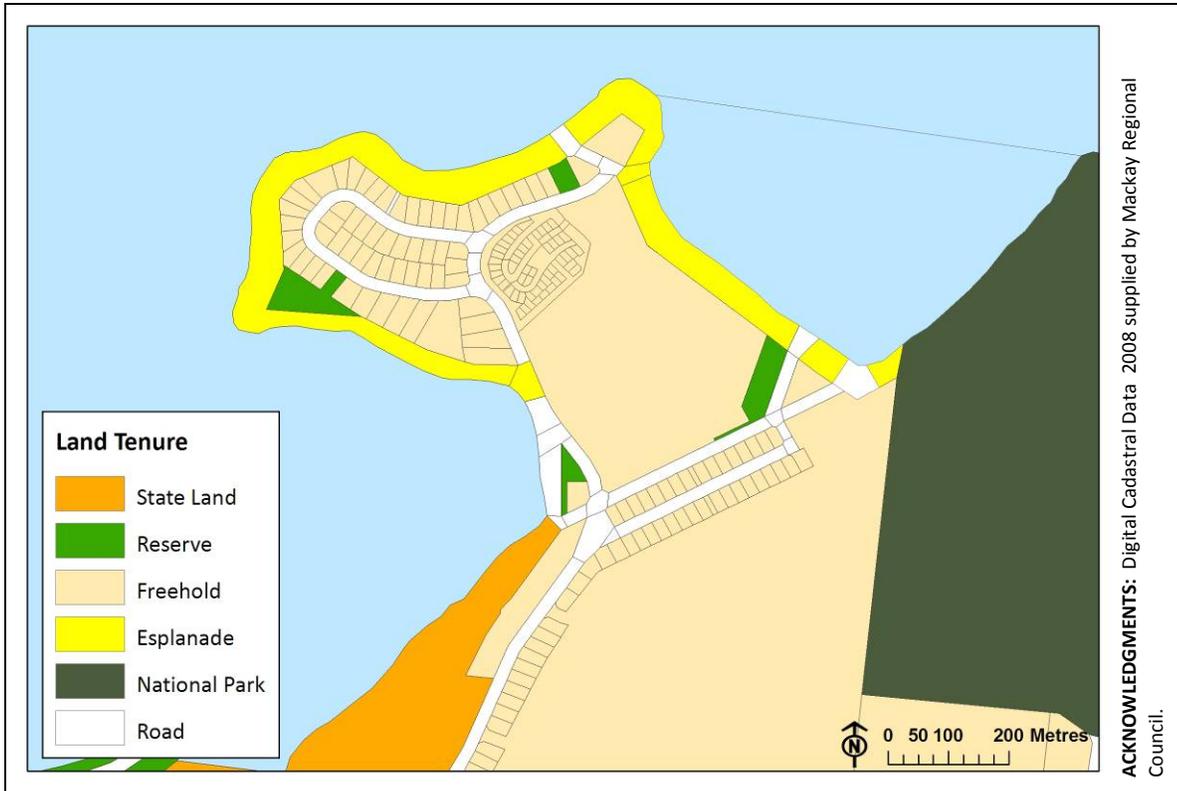
Figure 2: Land tenure Holiday Bay

Holiday Bay is a small residential settlement consisting predominantly of Freehold tenure zoned as Village (Figures 2, 3). Holiday Bay Resort occupies a large Freehold block in the centre of the beach unit, backing much of the sandy beach. An Esplanade, zoned as Open Space, surrounds the beach and headlands, and Cape Hillsborough National Park borders the beach to the south.

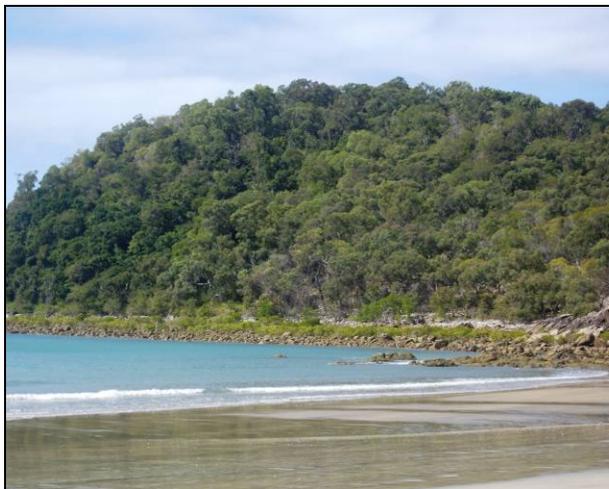
Figure 4: Mixed-eucalypt open to woodland forests on McBrides Point are protected by Queensland legislation.

The largest amount of remnant vegetation remains at the southern end of Haliday Bay beach under National Park tenure (Figure 6, Table 1). These mixed-eucalypt open to woodland forests are protected under Queensland legislation (Figure 4).

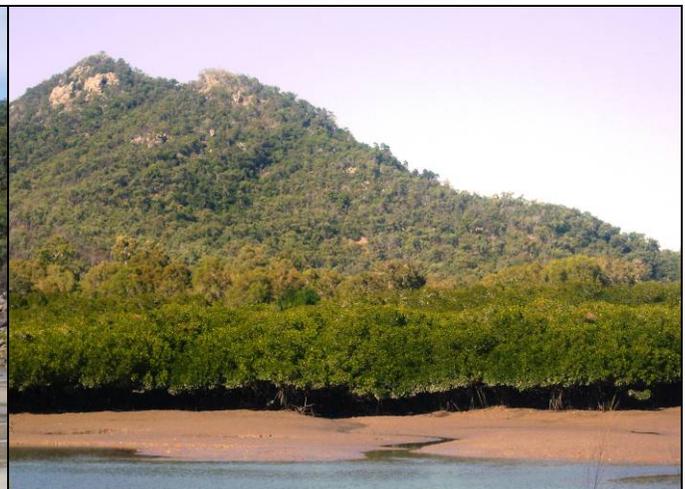
Figure 5: Extensive mangrove communities line Seaforth Creek in the west of the Holiday Bay beach unit.

Extensive mangrove and salt flat communities are present in the west of the Haliday Bay unit, associated with Seaforth Creek (Figure 5).

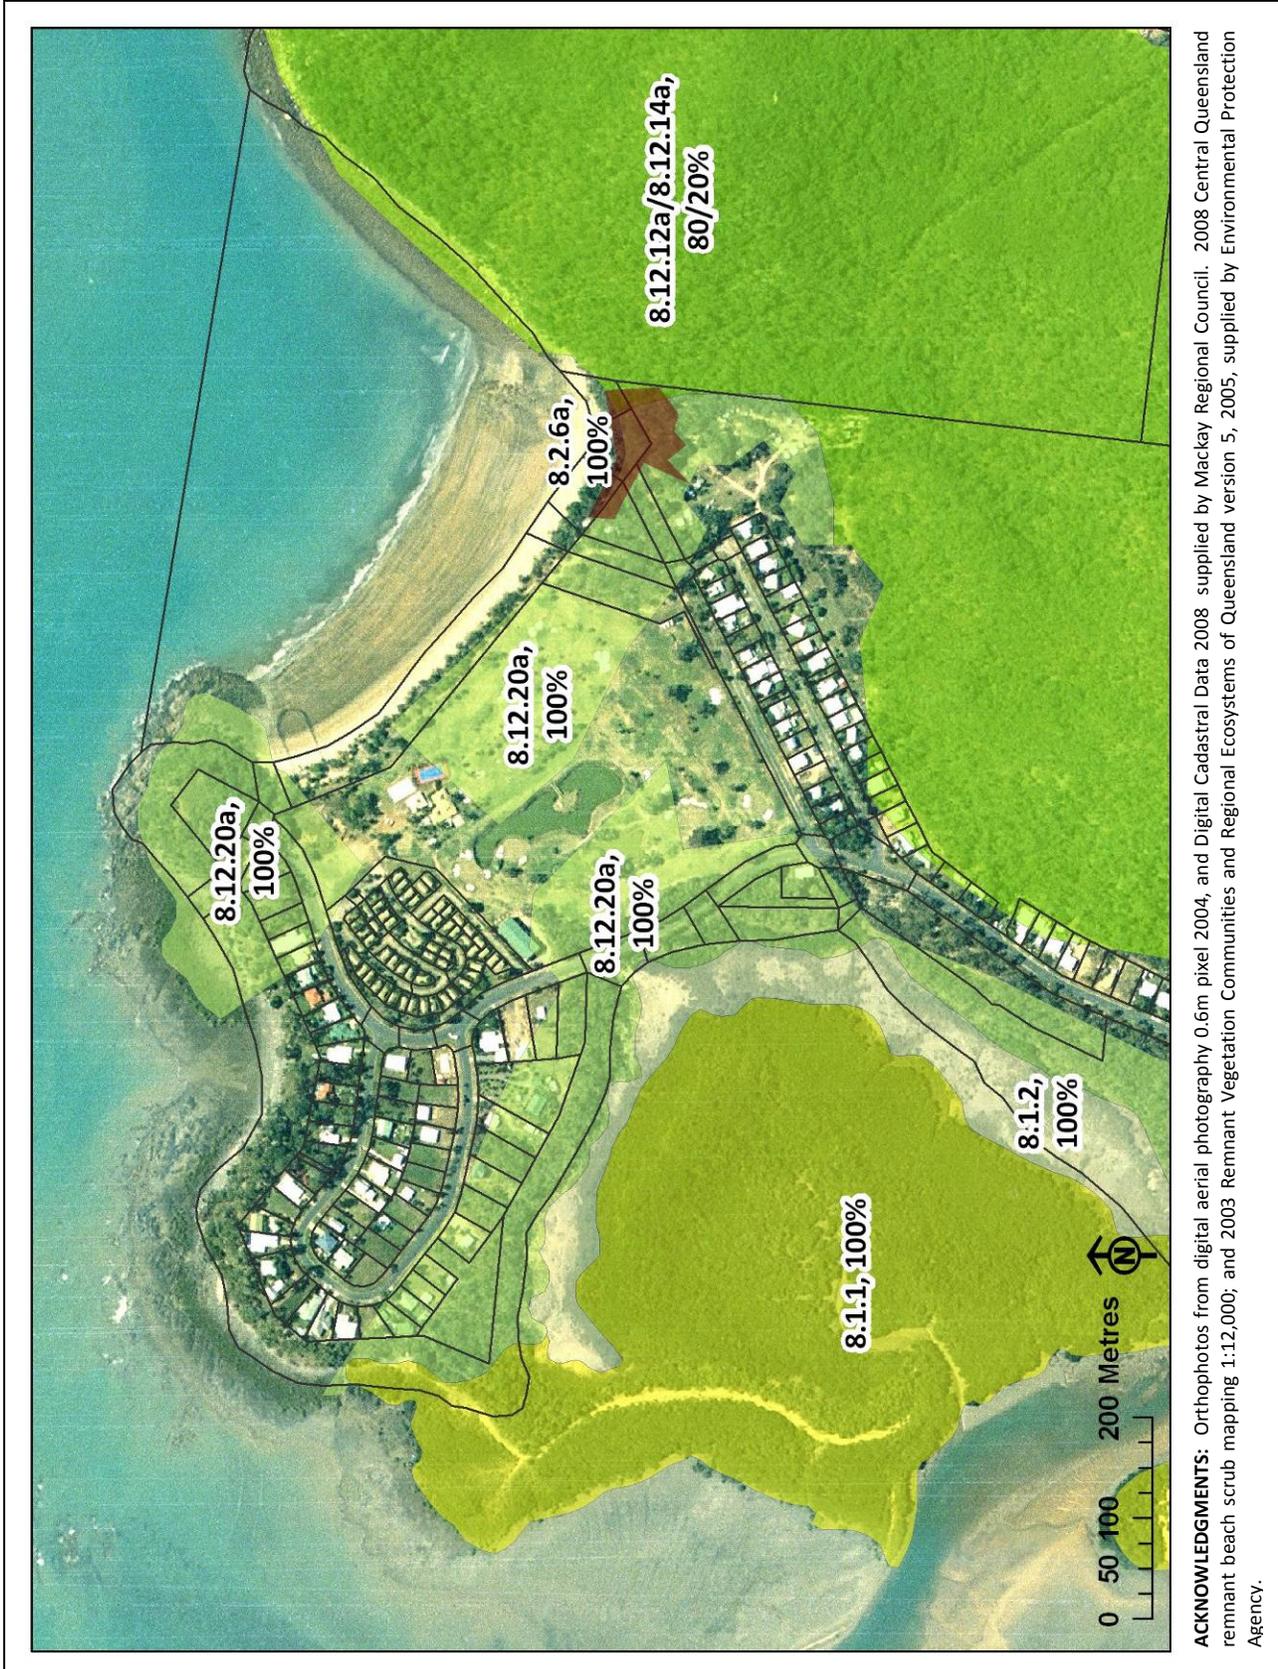
Figure 6: Remnant vegetation Holiday Bay beach unit

Remnant vegetation has been largely removed from the centre of the beach unit, with approximately only three hectares remaining on Esplanade tenure at the northern and southern ends of the beach, and on the western Reserve adjacent to the mangroves (Figure 6). The condition of this vegetation along the Haliday Bay sandy beach is threatened by weed invasion. Pre-clearing mapping shows that the entire headland was once a continuation of the mixed-eucalypt open to woodland forests present in the National Park (RE 8.12.20a) (Environmental Protection Agency, 2003).

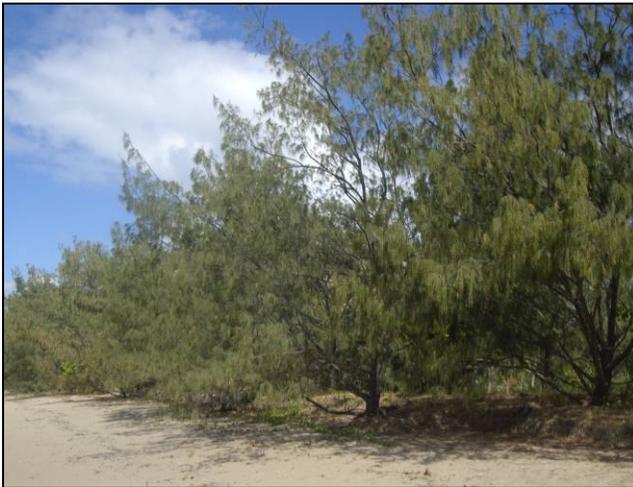
Figure 7: Haliday Bay beach retains partial dune vegetation zonation, with a thin band of colonising spinifex and casuarinas extending along much of the foredune.

The Haliday Bay sandy beach retains partial dune vegetation zonation, with a thin band of open casuarina woodland extending along much of the foredune (Figure 7). However, the Esplanade is only 15 metres wide, removing the potential for secondary or tertiary woodland zones. At the northern end of the beach, the maintenance of the recreational area prevents natural vegetation zonation (Figure 8).

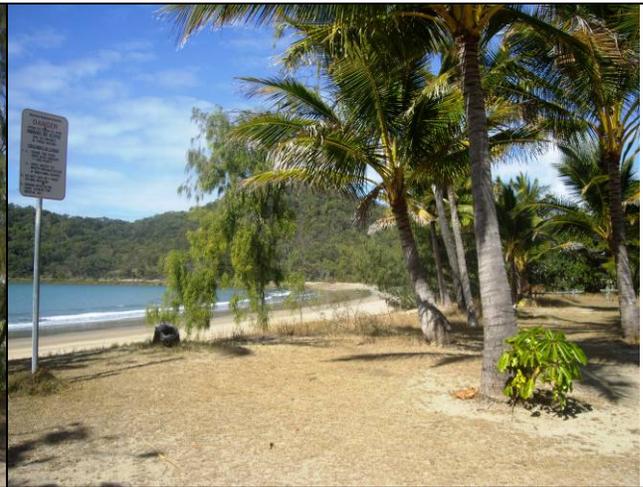
Figure 8: At the northern end of the Haliday Bay beach, natural dune zonation has been removed for the recreational area.

Two recreational areas are provided along Haliday Bay beach, with barbeques, shelters, playground, amenities, and a swimming enclosure (Figure 16). A pedestrian access path of 250 metres joins these two recreational areas, alongside a fence which defines the Esplanade from Freehold tenure (Figure 17). Given the short distance between several of these access points, and the significance this stretch of vegetation for marine turtle populations (section 2.3), it is recommended that access paths four and five be removed as a formal beach access points (Figure 18). Unrestricted vehicle access to the foredune and beachfront in the northern recreational area (Figure 8) compacts sand and prevents natural regeneration, and should be fenced to exclude vehicles.

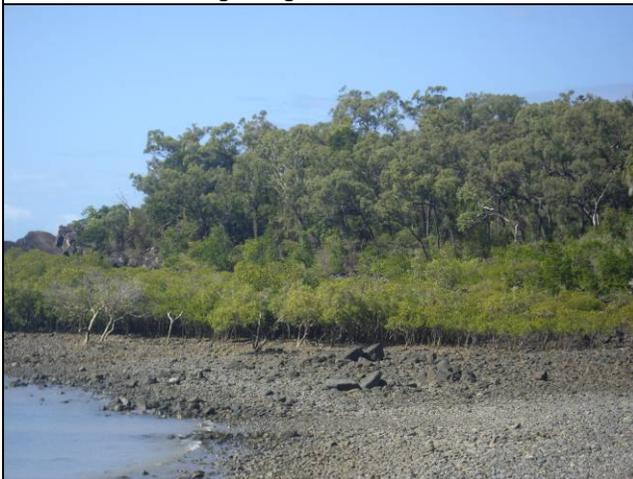
Figure 9: Mangrove communities line the low energy rocky foreshores in the Haliday Bay beach unit.

Beyond the sandy beach, the Haliday Bay coastline is comprised of rocky foreshores. Natural vegetation zonation remains largely intact in these areas and includes a variety of; low energy mangrove-lined foreshores (Figure 9), rocky headland vegetation (Figure 10), and mixed-eucalypt communities extending directly from the rocky foreshore.

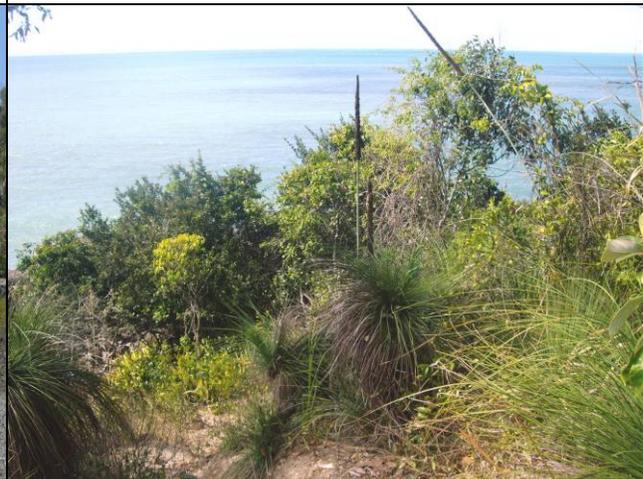
Figure 10: Vegetation on the headland north of Haliday Bay beach.

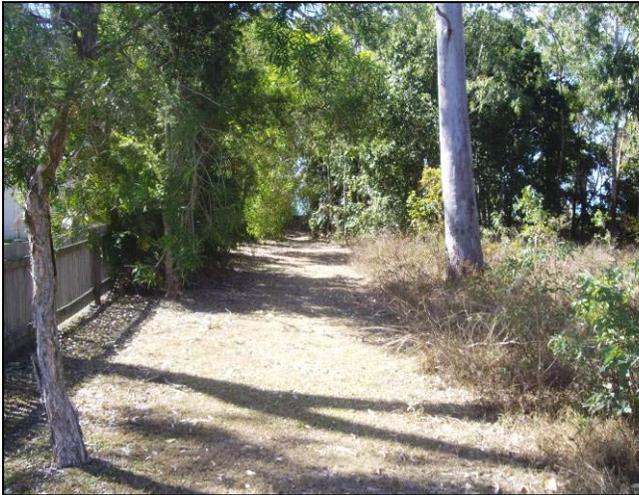
Figure 13: Access 1 to the north facing rocky forshore from Blue Beach Boulevard.

There are six designated beach access points provided with various fencing, signage, and associated infrastructure in the Haliday Bay beach unit (Figure 19). Five of these are associated with the Haliday Bay sandy beach, and the sixth provides access to the north-facing rocky foreshore from Blue Beach Boulevard (Figure 13). A public boat ramp is provided at the southern end of the beach (Figure 14) and aquatic transport from the Freehold property are permitted on one of the Esplanade access points (Figure 15).

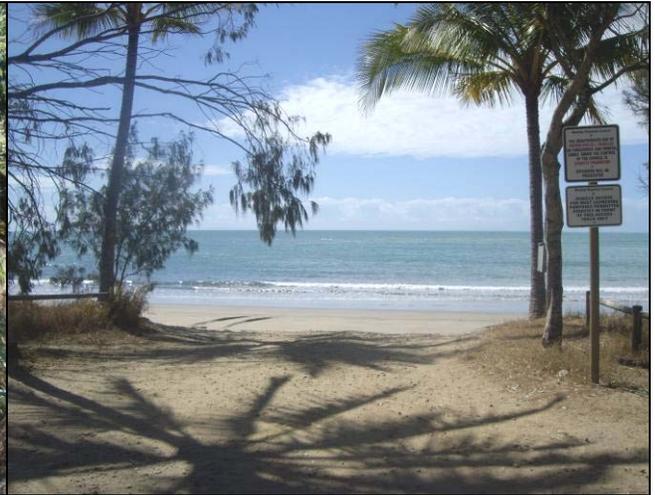
Figure 14: Boat ramp access on Holiday Bay Esplanade.

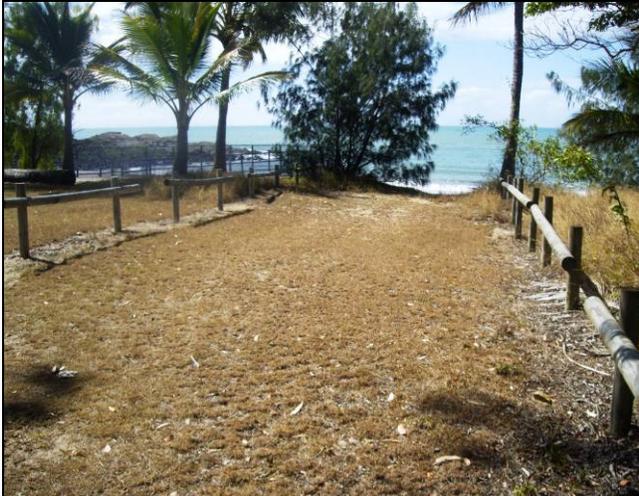
Figure 15: Access 3 on Holiday Bay Esplanade provides for the use of aquatic transport from the adjacent Resort.

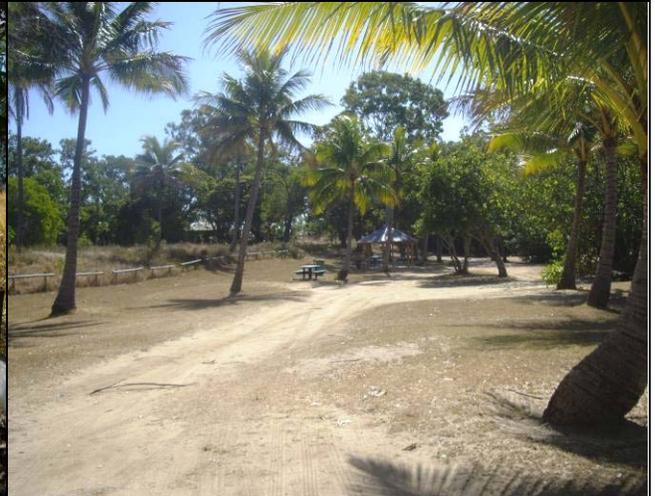
Figure 16: Recreational area associated with swimming enclosure on Holiday Bay Esplanade.

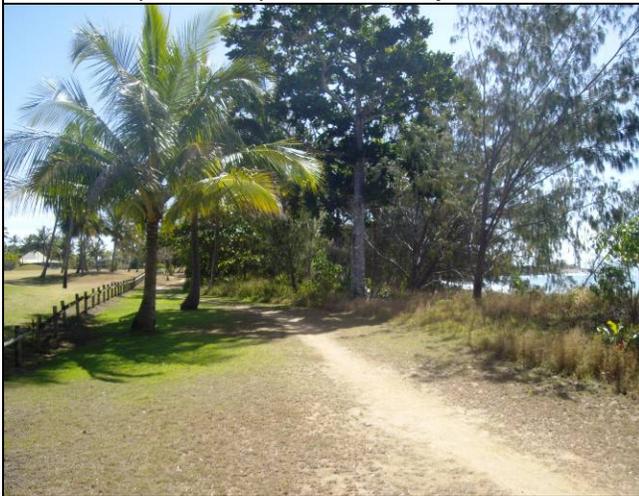
Figure 17: A pedestrian walkway joins the two recreational areas, adjacent to the Freehold property.

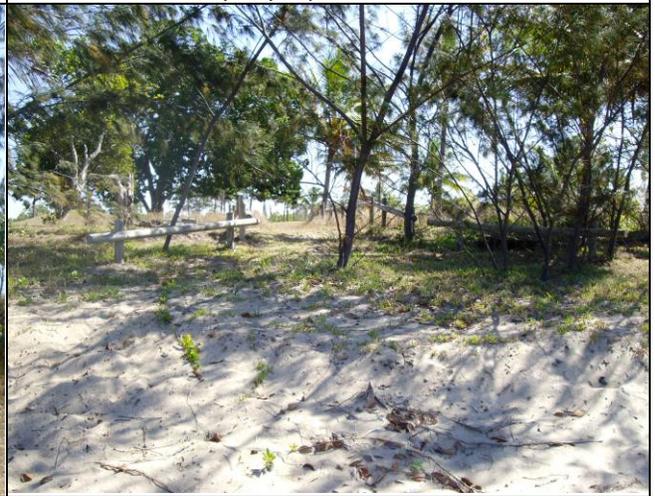
Figure 18: Access 4 on Holiday Bay beach Esplanade is only 60 metres from Access 3.

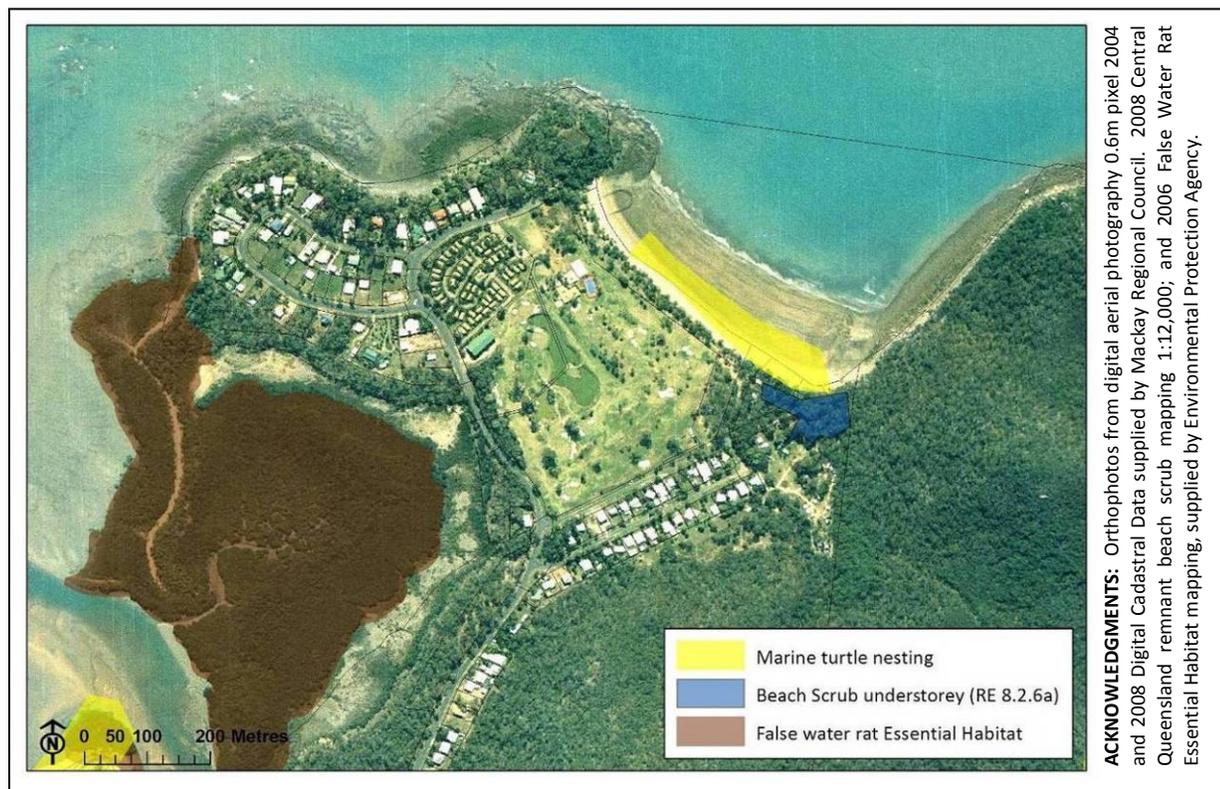
Figure 20: Wildlife values Haliday Bay beach unit

The vulnerable false water rat (*Xeromys myoides*) Essential Habitat covers the mangrove communities on the western side of the beach unit, lining Seaforth Creek (listed ‘Vulnerable’ by *Queensland Nature Conservation Act, 1992*). Although no other Essential Habitat mapping is currently available, beach scrub ecosystems are considered to provide habitat for the listed northern quoll (*Dasyurus hallucatus*), rusty monitor (*Varanus semiremex*), and coastal sheath-tail bat (*Taphozous australis*). The Haliday Bay beach unit contains a small pocket of eucalypt and acacia open forest with beach scrub understory (RE 8.2.6a) at the southern end of the beach (Figure 20). This condition of this community is threatened by weed invasion.

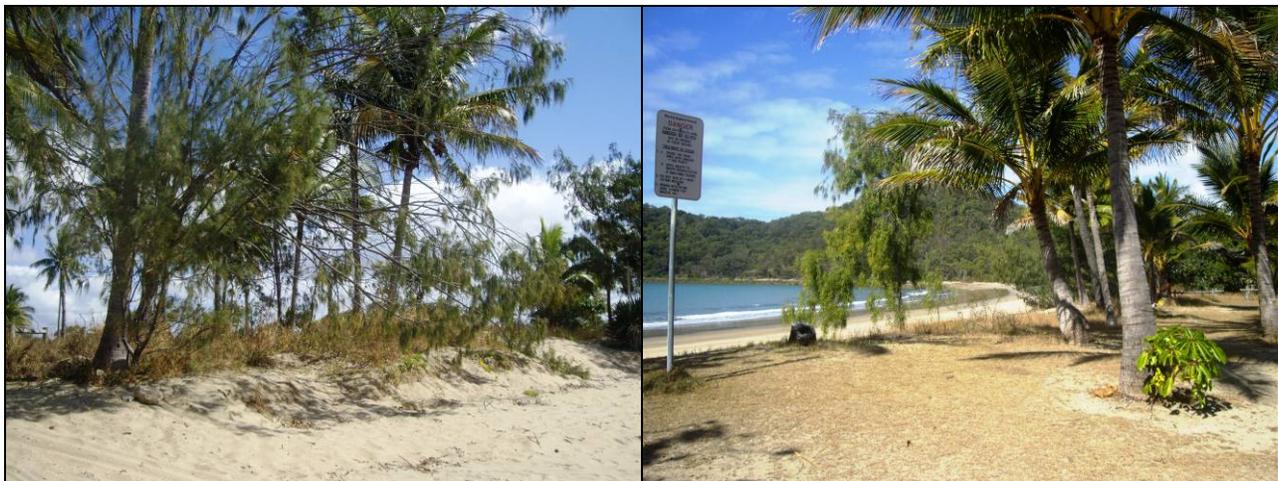
Figure 21 and 22: Some sections of Holiday Bay beach front are lacking, or have very sparse, native vegetation to stabilise the dunes, leaving them more vulnerable to erosion processes.

Development has been excluded from the erosion prone area in the Holiday Bay beach unit, with the exception of an eastern portion of the Holiday Bay Resort (Figure 23). The retention and maintenance of the Esplanade buffer zone is important to prevent threats to property boundaries and infrastructure into the future. Some sections of frontal dune along Holiday Bay beach are lacking, or have very sparse, native vegetation, leaving them vulnerable to erosion processes (Figures 21, 22). Improving the condition of the dune vegetation using weed control and revegetation is recommended.

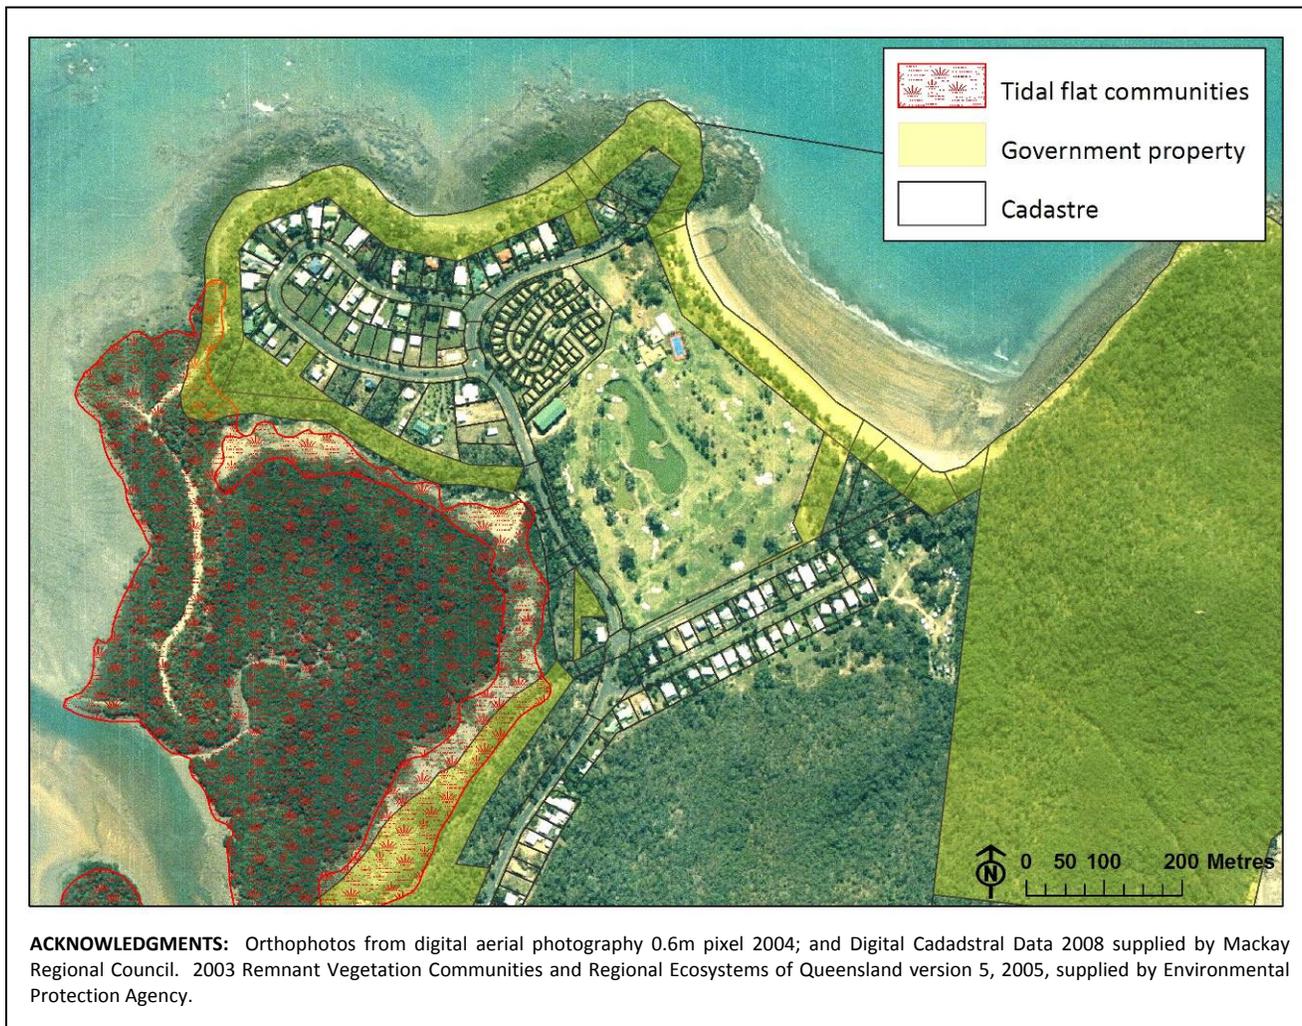
Tidal flat communities extend in from Seaforth Creek to the margins of the Haliday Bay Road and residential area (Figure 24). This precludes the possibility of any expansion of these salt marsh communities as sea level changes occur.

Figure 24: Current extent of tidal flat communities Haliday Bay beach unit (Landzone 1)
