SHEET 1 OF 1		WORKS JOB No.		DRAWING No.		AMEND.	
STILLING POND (DE-WATERING)		A3-6843		A			
DIRECTOR ENGINEERING SERVICES <i>S. M. Holley</i> STUART HOLLEY RPEQ 8948		DATE 20.12.11		DATE 12/12/11		DATE 12/12/11	
DRAWN PDG	DESIGNED PDG	CHECKED PDG	SIGNED PDG	SIGNED PDG	SIGNED PDG	SIGNED PDG	SIGNED PDG
SURVEY SURVEY FILE No		LEVEL DATUM AHD		MERIDIAN MGA 55		MANAGER TECHNICAL SERVICES G. Hawes RPEQ 5693	
NO. DATE A 18/11/11		DESCRIPTION ISSUE FOR CONSTRUCTION		APPVD		AMENDMENTS AND REVISIONS	
FILE NAME DESIGNDOCUMENTS\SEC STD DRAWINGS...

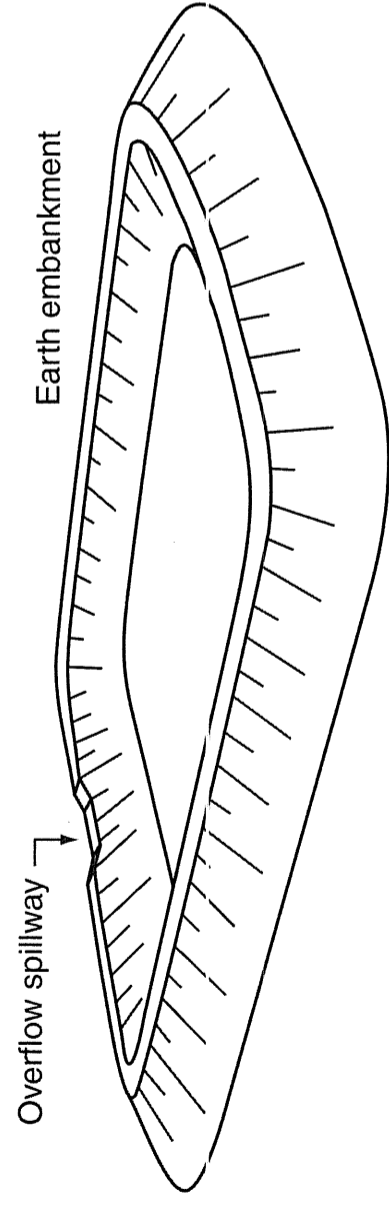
**(a) Stilling pond with overflow spillway**
