DRINKING WATER QUALITY MANAGEMENT PLAN **ANNUAL REPORT**

FINANCIAL YEAR **2021-2022**

This is the Drinking Water Quality Management Plan (DWQMP) report for Mackay Regional Council for the financial year (FY) 2021 – 2022.

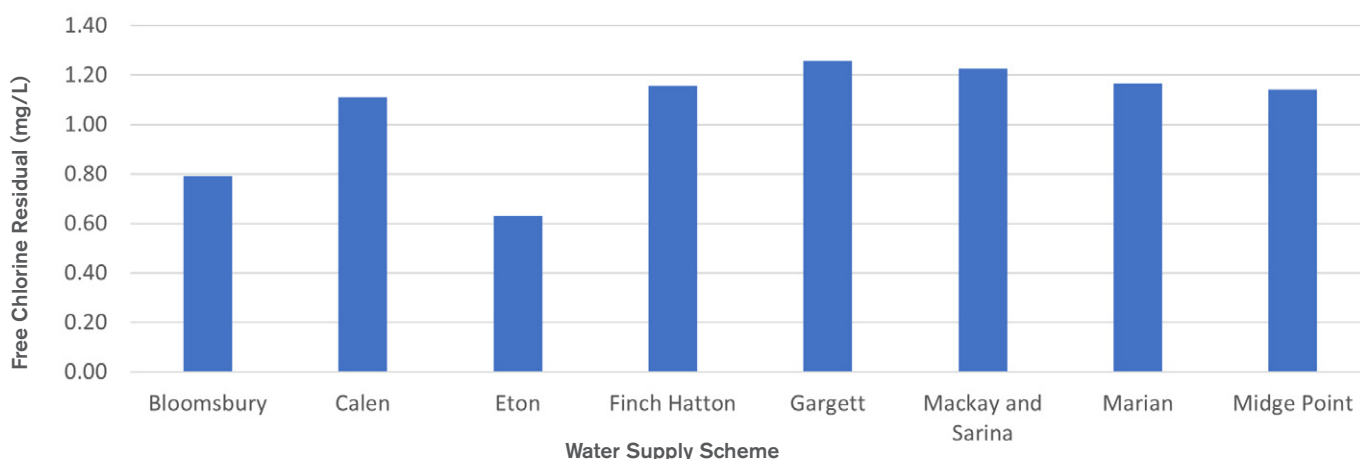
Figure 5 - 1 Average free chlorine residual FY 2021-2022

Re-chlorination systems are implemented within Mackay Regional Council's Mackay and Sarina and Midge Point reticulation networks to ensure that disinfection of drinking water is maintained and safe drinking water is supplied to customers. Re-chlorination systems are set up at locations within the reticulation network where historical water quality data has provided evidence of low-to-nil free chlorine residual in the drinking water. The presence of free chlorine residual in drinking water indicates that the water has been fully disinfected. Lack of or low free chlorine residual increases the risk to consumers if contamination does occur, as the water does not have the capacity to disinfect additional contamination. Re-chlorination systems are operated to ensure the free chlorine residual in the drinking water is maintained at a level which confirms full disinfection to the extremities of the water network. The average free chlorine residual recorded in each reticulation network for FY 2021-2022 is presented in Figure 5 - 1.

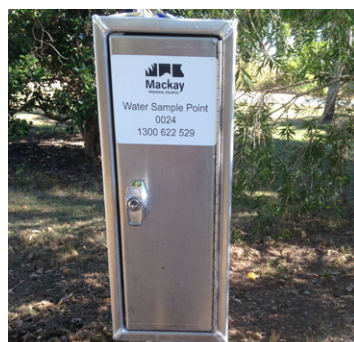
Figure 5 - 2 Water sample box

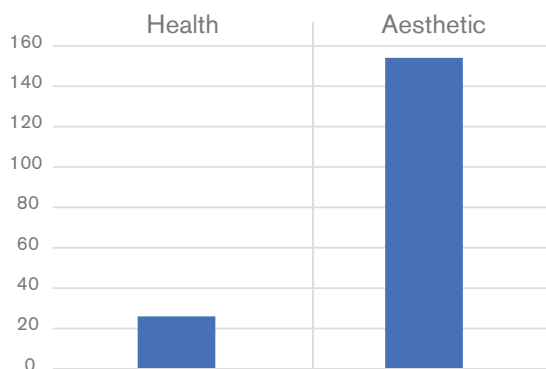
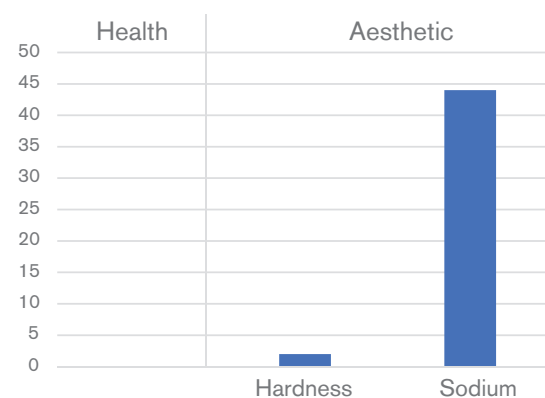
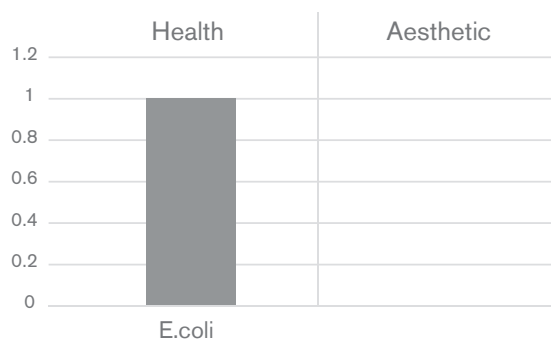
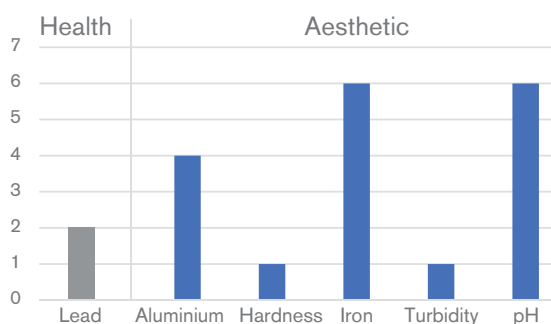
Figure 6 - 1 Results of the assessment of water quality data – exceedance breakdown

Table 6-2 below provides the results of the assessment of water quality data from the verification monitoring undertaken between July 1, 2021 and June 30, 2022 against ADWG health and aesthetic guideline values. A breakdown of ADWG health and aesthetic guideline value exceedances (excluding dissolved oxygen and total chlorine exceedances) per water supply scheme is provided in Figure 6 - 1 and Table 6 - 3.
