SETTLING POND (DE-WATERING)
SHEET 1 OF 1
WORKS JOB No. -
DRAWING No. A3-6840
AMEND. A

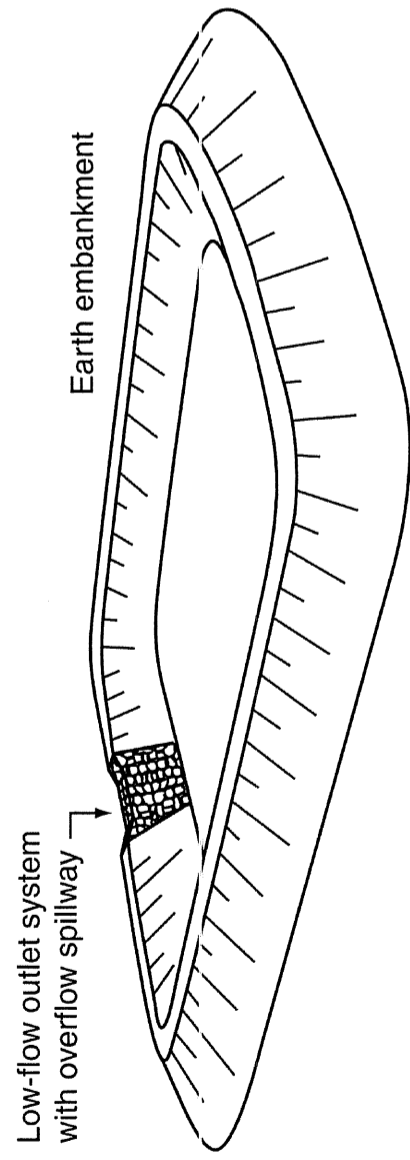
(a) Settling pond with rock filter dam low-flow outlet

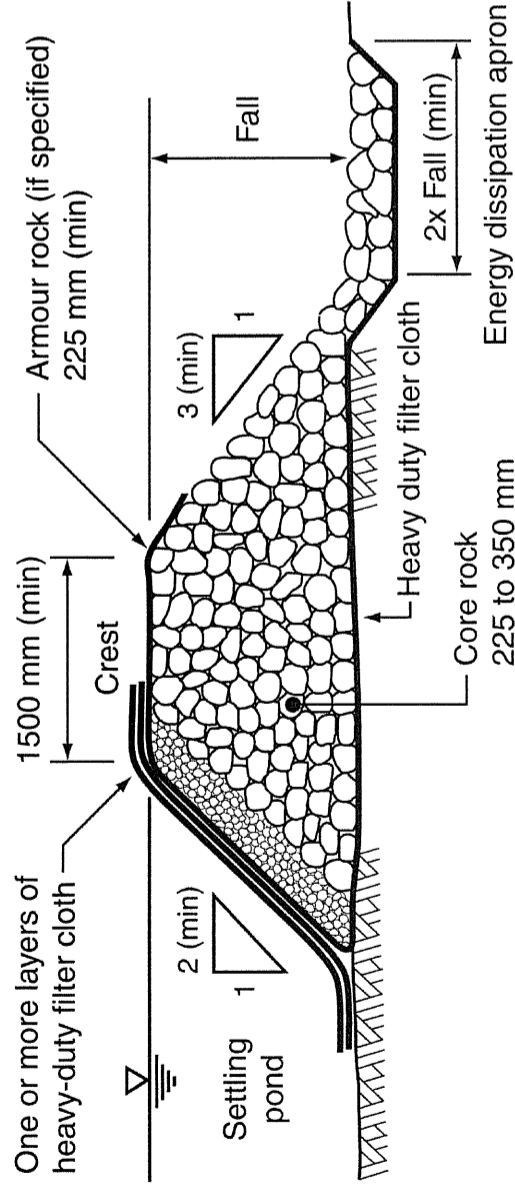
(c) Rock filter dam low-flow outlet with geotextile filter

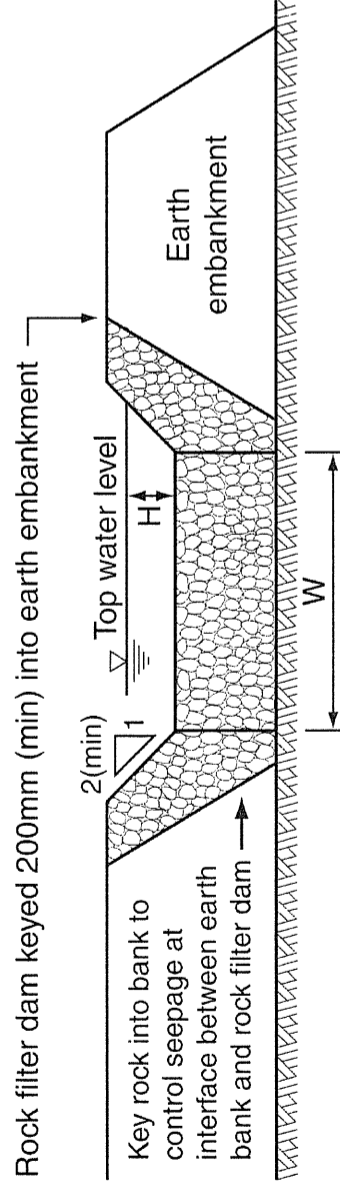
(e) Rock filter dam with overflow spill

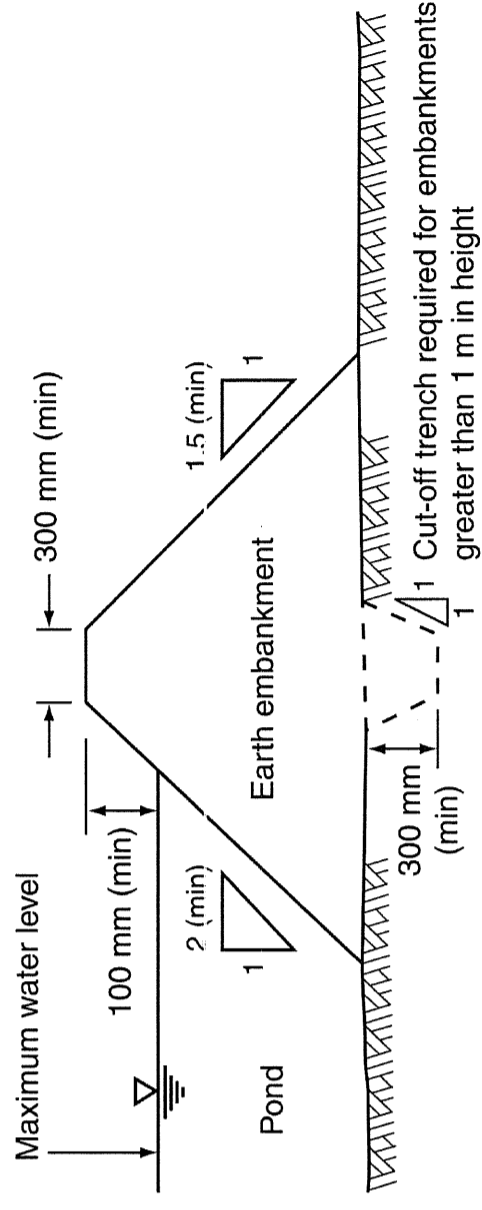
(b) Typical profile of earth embankment

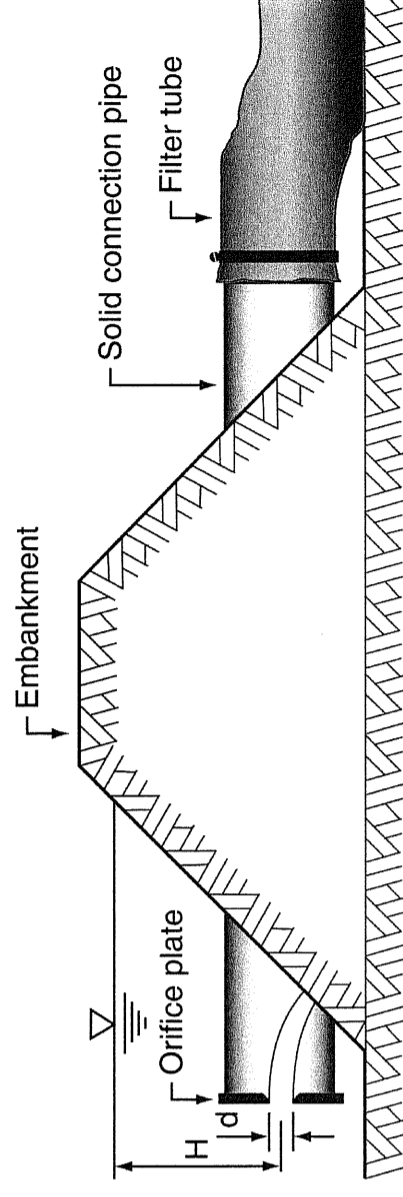
(d) Filter tube low-flow outlet with orifice plate

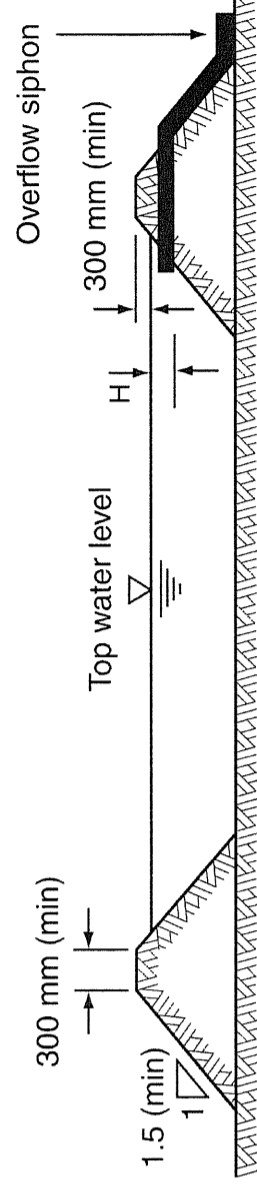
(f) Siphon overflow system
