**COARSE SEDIMENT TRAP**

SHEET	1	OF	1
WORKS JOB No.			
DRAWING No.	A3-6784	AMEND.	A

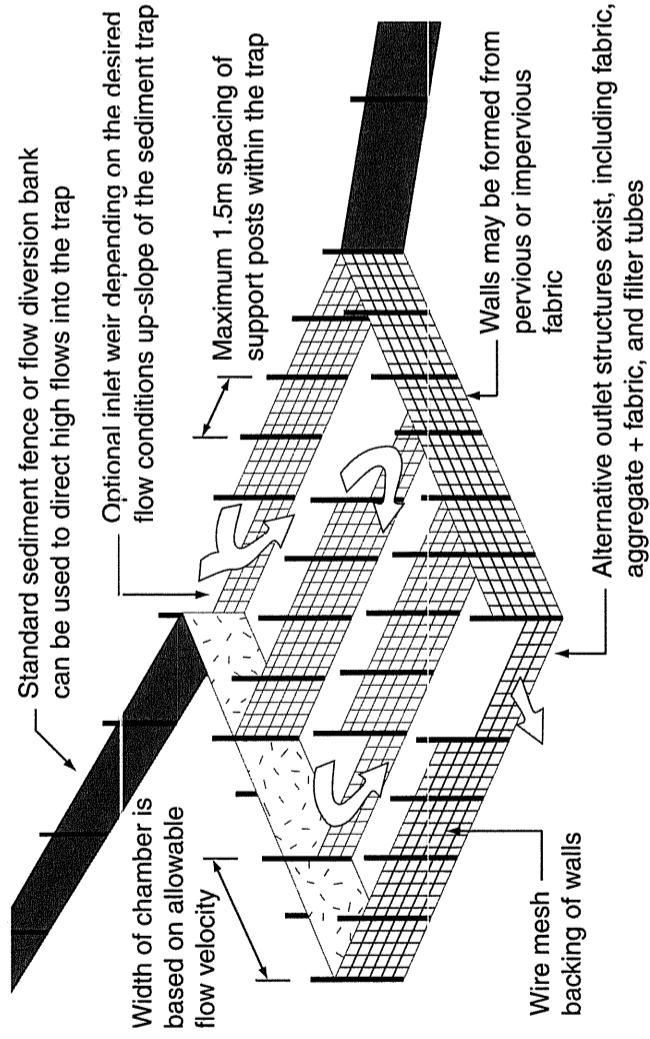
**(a) Typical layout of a coarse sediment trap**

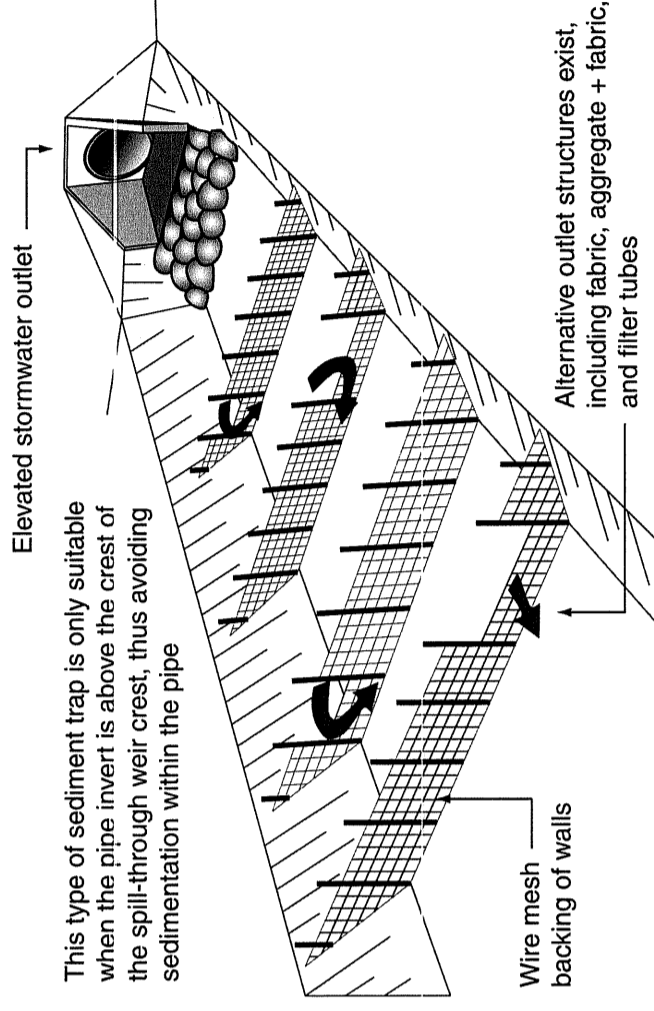
**(b) Coarse sediment trap located at pipe outlet**

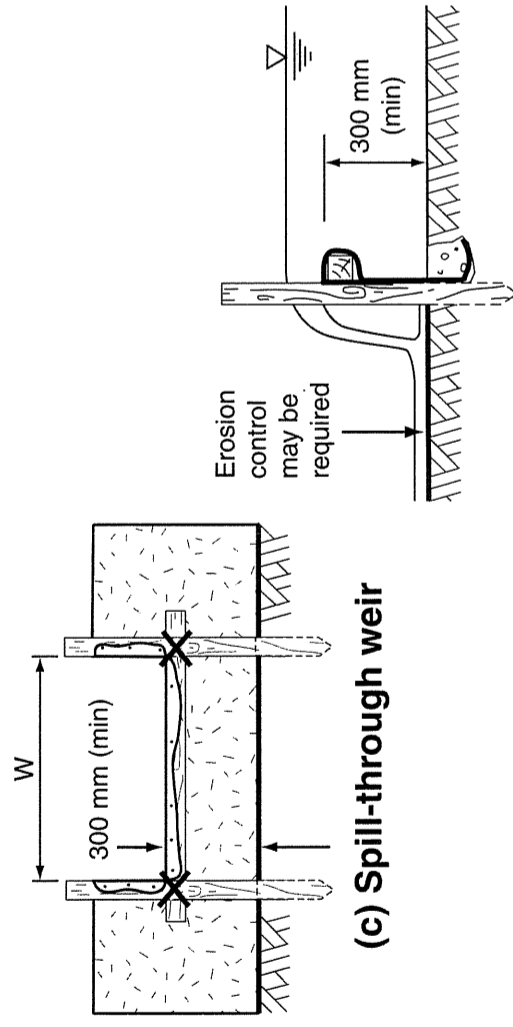
**(c) Spill-through weir**

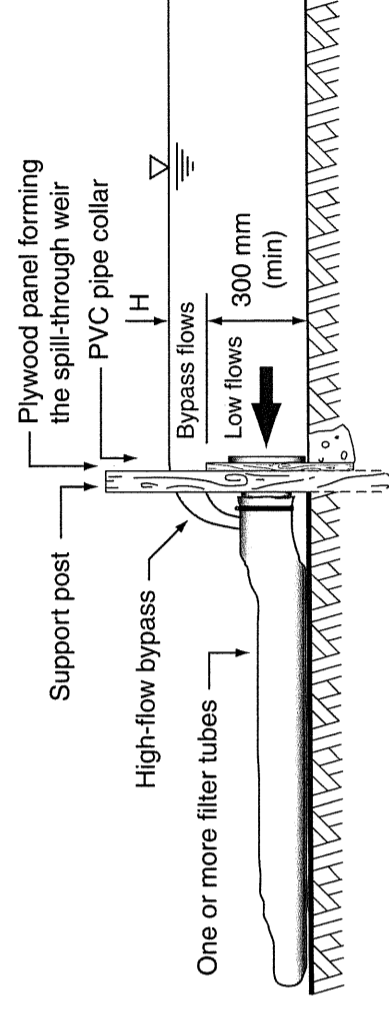
**(e) Alternative outlet structure incorporating a filter tube**

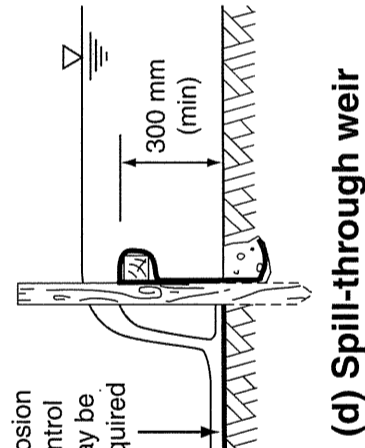
**(d) Spill-through weir**
